# St. Clair River Restoration Assessment Project Report

St. Clair Region  
Conservation Authority

April, 2007

## St. Clair River Shoreline Restoration Assessment Project Report

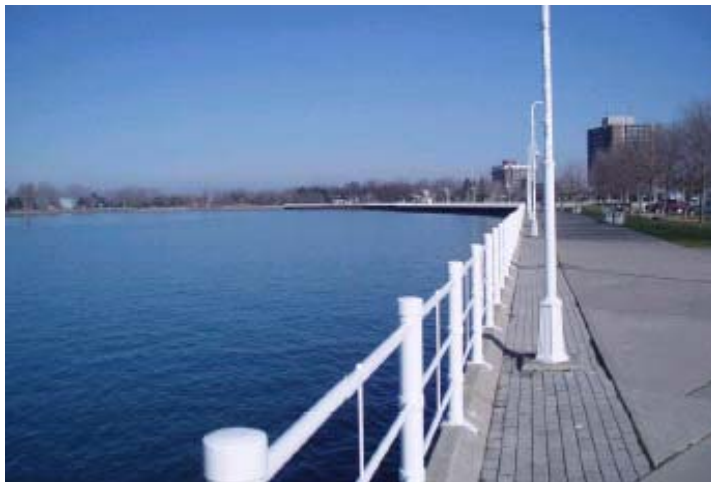
Photo 3.1.1 ST0045, Bayshore Park, Sarnia

The vast majority of bulkheads are steel sheet piling, 1% of which are in poor condition (Figure 3.1.3). These bulkheads are in very good condition, which is directly related to the adjacent land use. The largest continuous reach of steel sheet piling is in a series of Sarnia owned parks, including; Centennial Park, Bayshore Park, Mackenzie Park and Seaway Park. These parks are well maintained and the shoreline protection is in very good condition. Other stretches of steel sheet wall belong to the LAWSS Treatment Plant, Point Edward Charity Casino and Transport Canada. All of which have enough financial resources and motivation due to aesthetics to maintain reasonable shoreline protection.

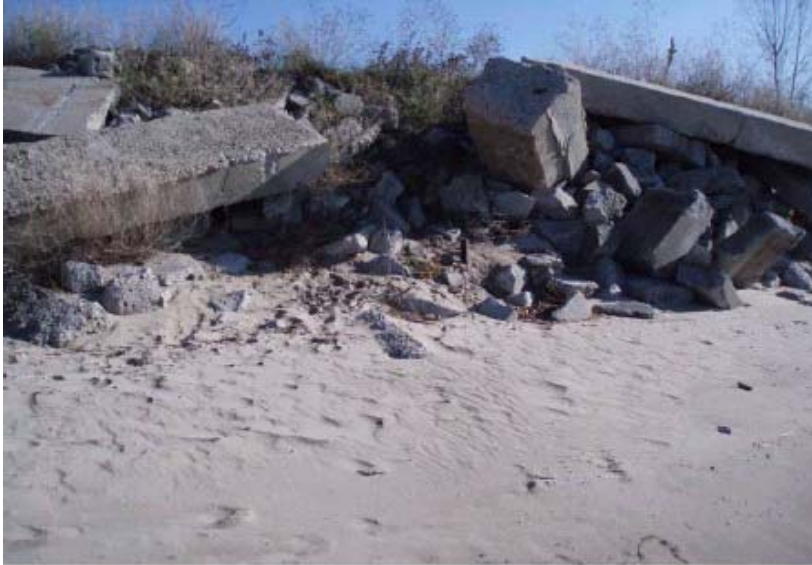
Photo 3.1.2 ST0016, Sarnia 2007

The spit of land 300m south of the casino presents an interesting opportunity for enhancement. There is 676m of continuous shoreline that could be enhanced with no apparent land use to restrict construction designs. This piece of land is used primarily by the public for walking and fishing, however, a development proposal does exist. The proposed residential development would likely require replacement or restoration of the existing shore protection. The shoreline consists of mostly concrete slabs, undermined by erosion and is clearly ineffective.

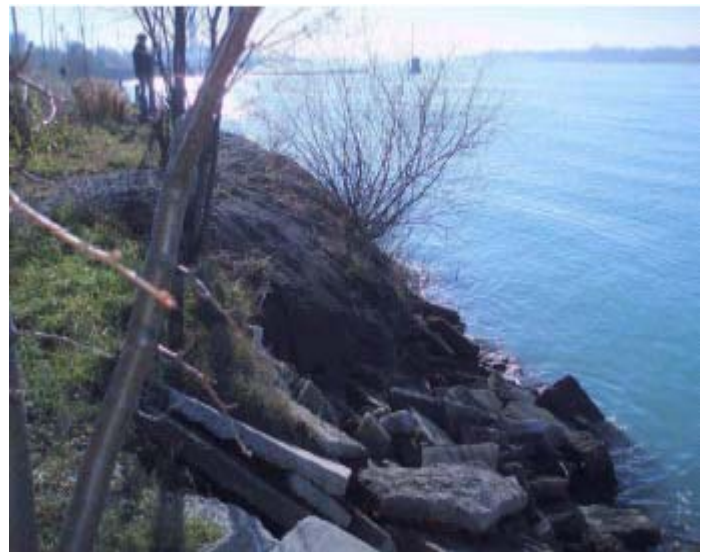
Photo 3.1.3 ST0052, Sarnia 2007

Ferry Dock / Former CN Lands have already been identified as a potential area for rehabilitation. Draft plans for an armour stone/rip rap revetment have been drawn and a Class Environmental Assessment is currently underway to obtain required permits and to support requests for funding. This section is 720m long and consists of concrete rubble and slabs with a poured concrete slush cap. Erosion is quite evident and will clearly continue without replacement and/or enhancement.

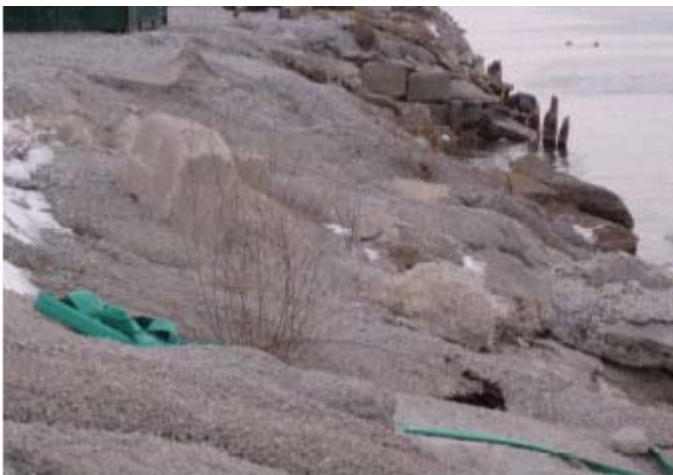
Photo 3.2.1 ST0840, Sarnia 2007

The north end of Chemical Valley has a few potential areas for rehabilitation. There are four structures, one 115m and 3 @ 58m; each separated by an average of 225m. The longest one (115m) is a concrete seawall in ruins and is in need of immediate attention. The land adjacent to the structure is used for aggregate storage, but no permanent

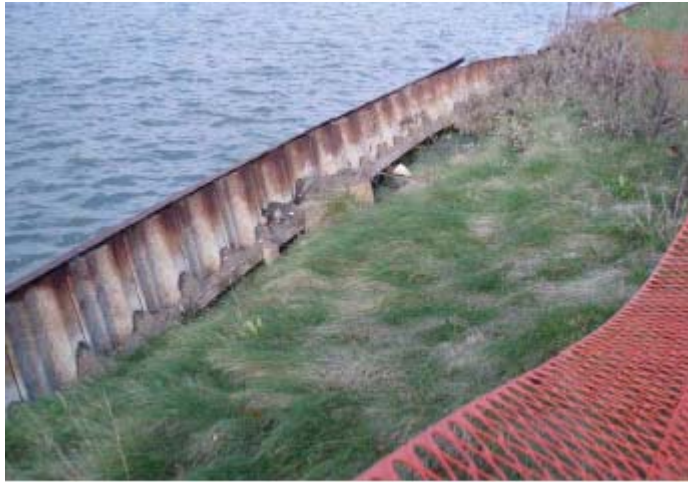
Photo 3.3.1 ST068, Corunna 2007

Guthrie Park is located north of Corunna and is the first structure found in this section. It is owned by the Township of St. Clair and represents the single largest opportunity for shoreline enhancement in this section, with a length of 764m. It has already been identified as a potential area for enhancement and draft designs for new protection are being undertaken. This site would be ideal because of its length, composition and proximity to numerous residential homes with steel walls. This site would act as an example of soft-shore engineering and will help encourage residents to switch to this type of protection.

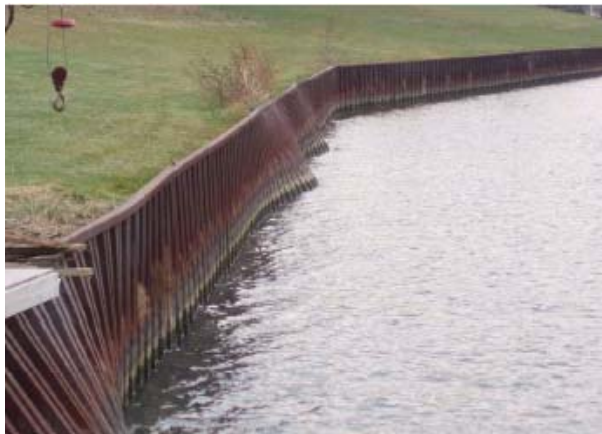
Photo 3.3.2 ST0080, Corunna 2007

There is no other single property or structure that stands out as a candidate for enhancement or replacement, but there are a collection of potential sites of equal importance. The photo to the left is simply a typical bulkhead in this area that is representative of all potential sites for enhancement and will need repair or replacement as soon as possible. Specific sites for enhancement will likely come down to the willingness of the individual landowners. Potential candidate sites were assessed based on the following criteria: a minimum length of 80m, no on-shore structures within 10m and currently in poor condition (Table 3.3.4).

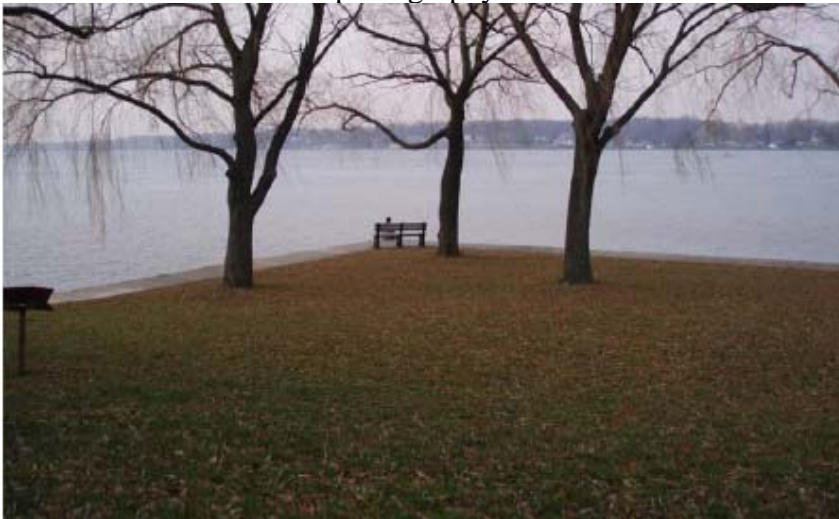
**Photo 3.4.1 - Mooretown Centennial Park, 2007**

Based on the comparisons of aerial photography from 1955, 1972, 1992 and 2003, three areas have noticeable alterations. The first area is Mooretown Centennial Park. It is clear from the aerial photographs that this area was not designated a park until after 1955. The existing steel sheet pile wall was only installed between the years of 1972 and 1992. The area for the park could be identified in 1972; however steel sheet pile walls are only evident in the 1992 aerial photography.

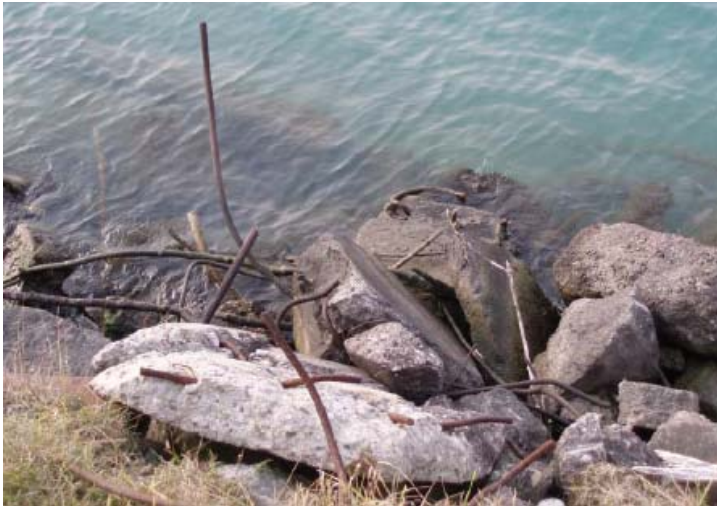
**Photo 3.4.2 – ST0196, Mooretown, 2007.**

The first photo shows concrete slab dumped into the water to protect the shoreline. This slab has a great deal of re-bar protruding from the recycled concrete. The use of this concrete is dangerous to human and wildlife safety. This type of rubble is common along this section of river and would be an excellent location to promote shoreline enhancement. This area of shoreline, due to its proximity to roadway and its slope would

best be replaced with a rip rap revetment. The recycled concrete shown in photo 3.4.2 stretches over 342 meters and consists of a mixture of concrete rubble, slabs, and steel sheet piling all in very poor condition. The possible construction is limited due to the adjacent gravel dock and the distance between the water and the road.

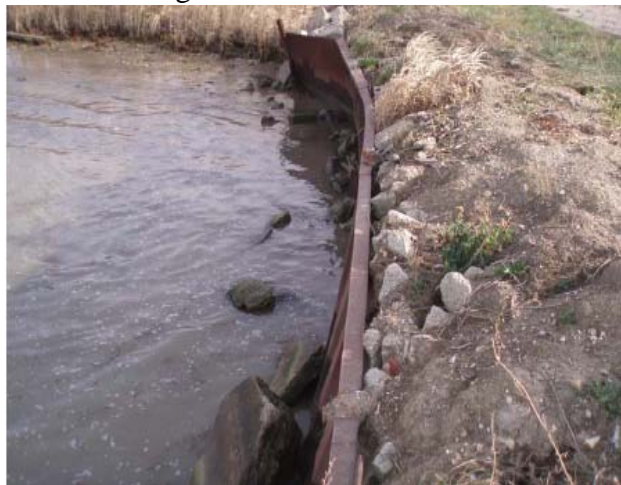
**Photo 3.4.3 – ST0283, south of Courtright, 2007**

Photo 3.4.3 shows a steel sheet pile wall that is in need of repair. This protection has begun to slant in the centre and flank at the ends. A great deal of soil has been used to fill erosion areas and is adding to the weight and force against one side without the equal amount of force from water energy or toe protection. By removing the steel wall, there would be a great deal of property loss by creating the slope, but the sloped revetment would benefit aquatic habitat. The evidence of the rocks near the bottom of the wall indicates that the slope would not have to be too slanted and would still allow for some green space.

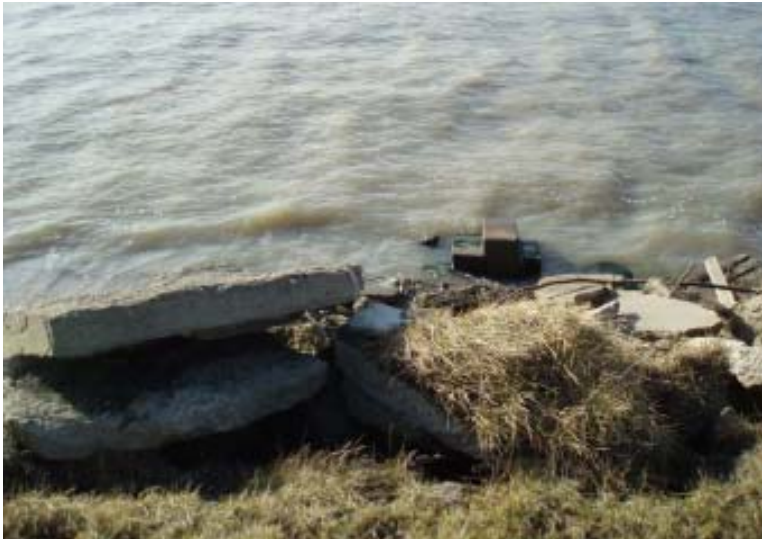
**Photo 3.5.2 – ST0359, Sombra, 2007.**

absence of filter cloth behind the structure, the soil is easily eroded away. To repair this shoreline, a possibility would be to replace the concrete slabs with rip rap stone and slope the revetment slightly to decrease the potential wave energy against the shoreline. Before any rip rap stone would be laid, a filter cloth would be used to decrease any possible erosion.

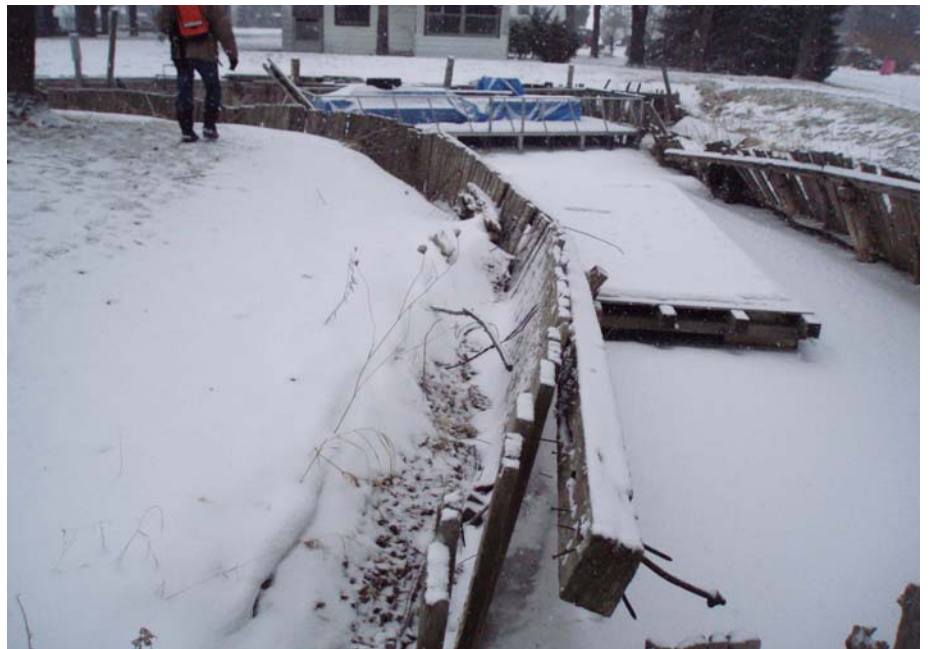
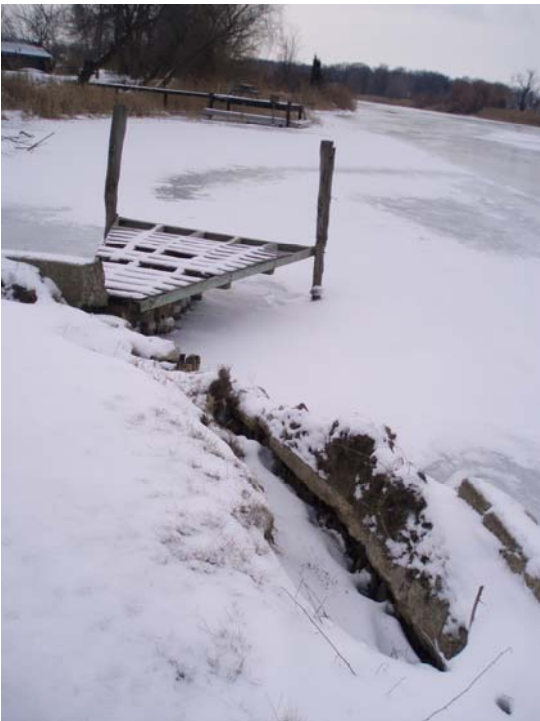
**ST0726 Bluewater Line, 2007**

Other sites include a site where a landowner has a combination of failing structures. The first section has an old concrete slab wall that is beginning to crumble, followed by a flanked timber piling bulkhead. The property ends with a concrete wall in ruins with most of the shoreline exposed and eroding. This property has limited space with an average of 10-12 m to the nearest on-shore structure
