# St. Clair River Restoration Assessment Project Report

St. Clair Region  
Conservation Authority

April, 2007

## St. Clair River Shoreline Restoration Assessment Project Report

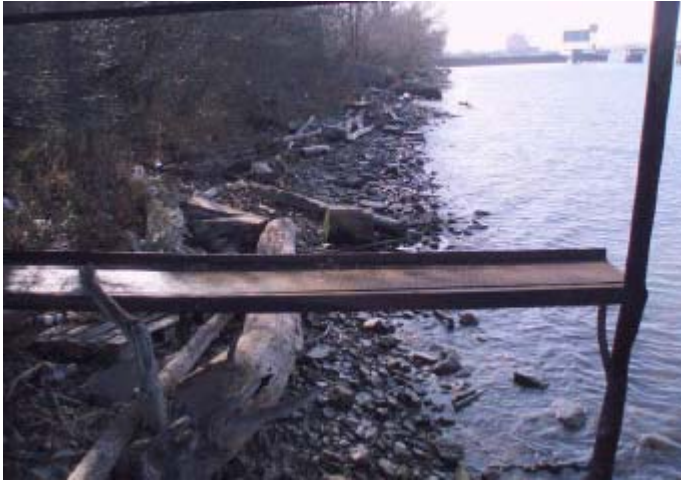
Photo 3.2.2 ST0064, Corunna 2007

The south end of chemical valley has two structures which offer little protection and have potential for enhancement. They are very similar reaches, one 249m (18m to road) and

one 232m (8m to road), totaling 481m. They are mostly concrete rubble, with other forms of debris, such as re-bar, scrap metal and tires. Both have very little protection and show numerous signs of erosion. Although the road is nearby, it is uphill and the potential for rehabilitation still exists. Some brush and trees are helping to retain the shoreline, however, under higher water levels it is clearly insufficient protection.

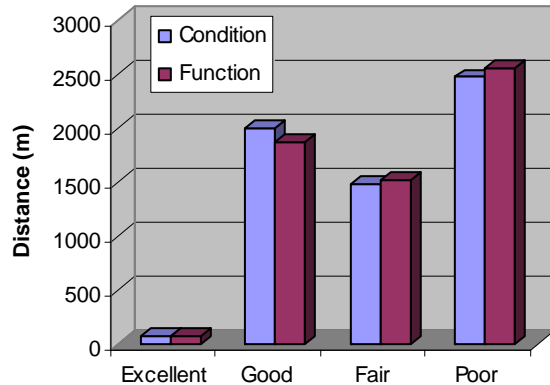
**Figure 3.3.1 Steel structure condition and function 2007.**

The greatest percentage of steel sheet piling is in poor condition, which suggests this section may have great potential for enhancement. Nearly 2500m of shoreline are lined with steel sheet piling in poor condition and 1500m are in fair condition. Assuming the

lifespan of walls in fair condition is around 10 years; compared to 0-5 years for walls in poor condition, that would provide 4000m of potential enhancement within the next 10 years. Due to the large amount of steel sheet pile, which is our target structure for replacement, this area should be targeted as a high priority area.

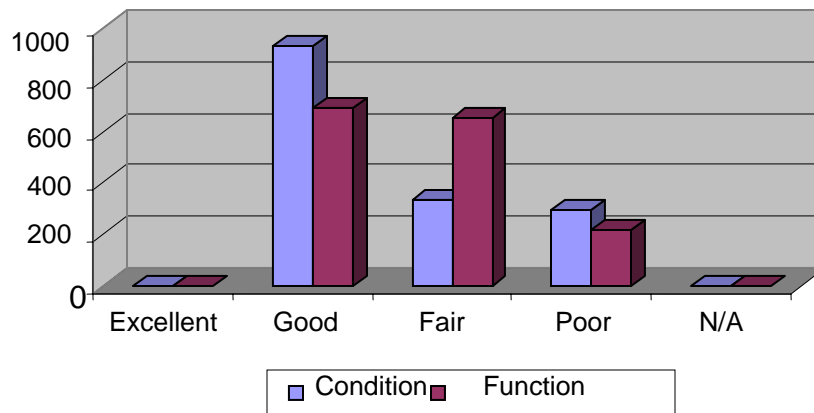
**Figure 3.4.2 – Condition and Function of steel protection structures in Courtright and the surrounding area, 2007.**

Based on Figure 3.4.2 it appears that most of the steel sheet piling in Courtright is in fair to good condition and is not in immediate need of repair. However the section of poor conditioned shoreline accounts for 20% (2148m), whether it is steel wall or any type of shoreline. The poor conditioned areas are important areas for rehabilitation and some are mentioned in the Future Opportunities section. The concrete structures are in worse condition than the steel sheet pile bulkheads and therefore are a greater priority for restoration (Figure 3.4.3).

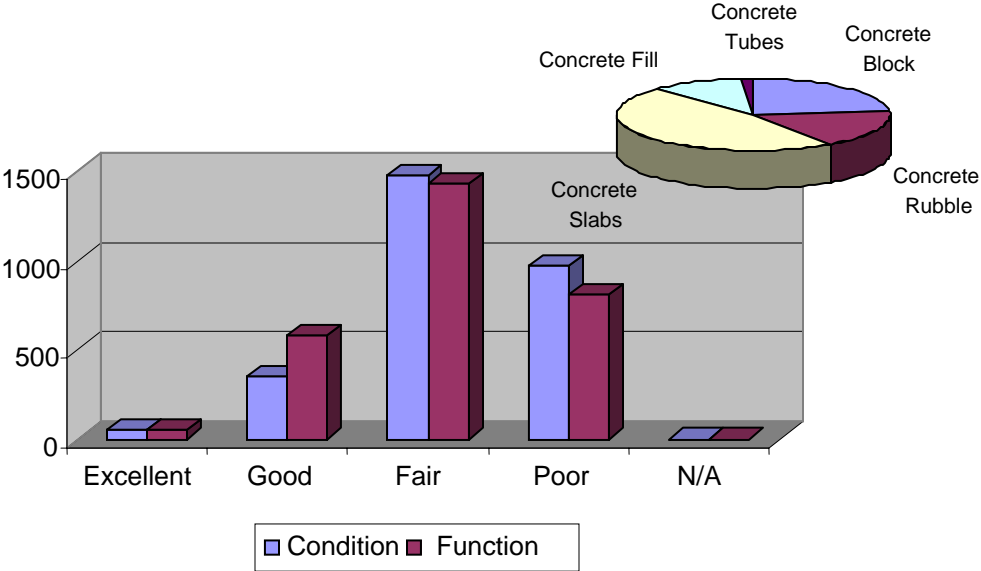
**Figure 3.4.3 – Condition, Function and Distribution of concrete shoreline protection structures in Courtright and the surrounding area, 2007.**

Of the 2148 metres in poor condition, some structures do not offer restoration possibilities because of the distance from the structure to the nearest building. If a building is less than 10 meters away from the shoreline, it is all but impossible to replace the structure with the ideal rip rap or armour stone. In some cases where a narrow revetment/rubble is in place, the existing protection could be replaced with a 2-1 rip rap slope. Based on the chart below, 388 meters of the shoreline have limited fish habitat and water quality restoration possibilities, while 293 meters have a great opportunity for improvement.

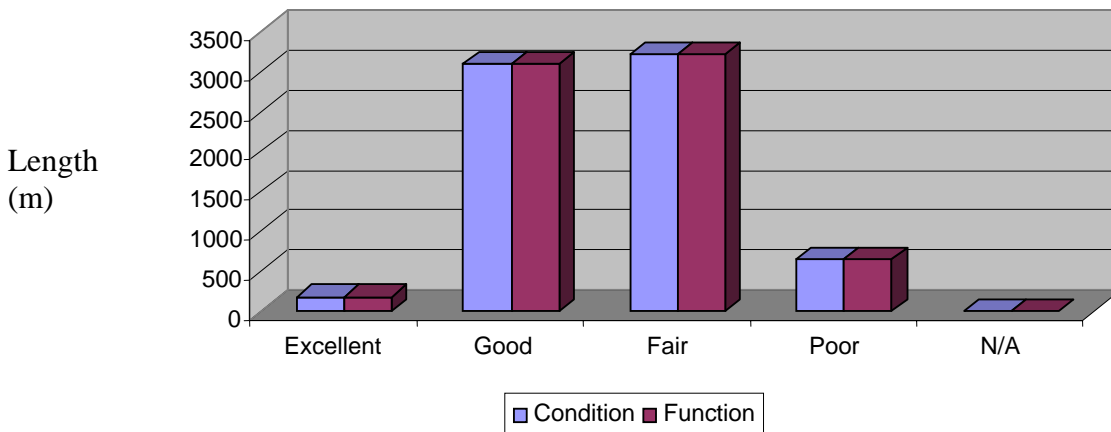
**Figure 3.5.2 - Condition, Function and Distribution of steel shoreline protection structures in Sombra and the surrounding area, 2007.**

Based on Figure 3.5.2, it is evident that the majority of the steel walls are in good to fair condition and may not need to be replaced in the near future. The ones in poor to fair condition are often restored and maintained by tightening the tighbacks. Although it would be ideal to remove as much steel wall from the shoreline, it is not always possible or the best solution depending on the existing development.

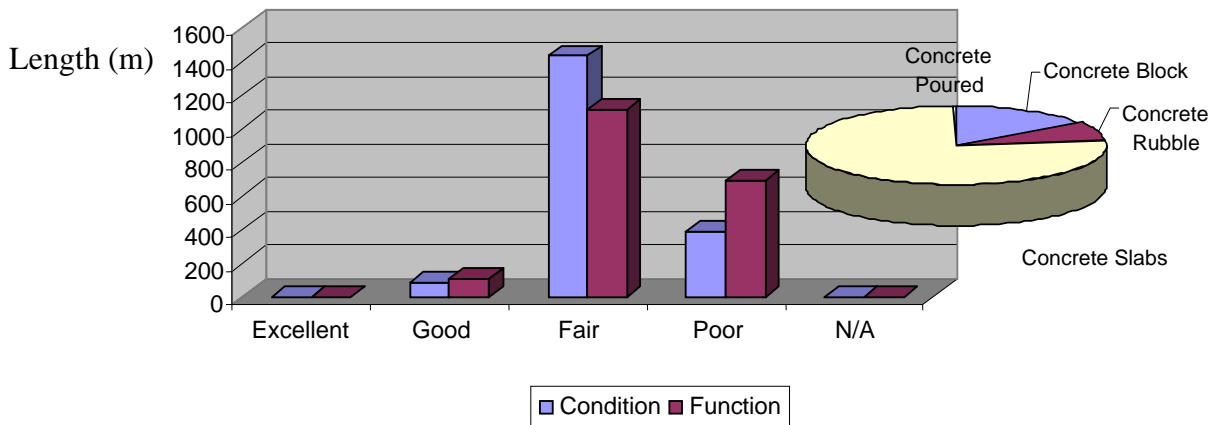
Figure 3.5.3 - Condition, Function and Distribution of concrete shoreline protection structures in Sombra and the surrounding area, 2007.

The condition and function of concrete structures differs greatly from the steel structures. For the most part, the concrete structures are either in fair or poor condition and may need to be replaced. The percentage of concrete structures is 18% whereas steel structures take up 66% of the total Sombra area. When looking at the map of the Sombra area, it is evident that the amount of bulkhead in need of repair outweighs the poor conditioned rubble or revetment. It is positive to note that out of the 10.7 kilometres of this area; only 12.8% (1195m) is in poor condition and in need of repair. Despite the low number of poor structures, only 1.7% (181.9m) of the Sombra shoreline is in excellent condition and all of that is steel sheet pile wall.

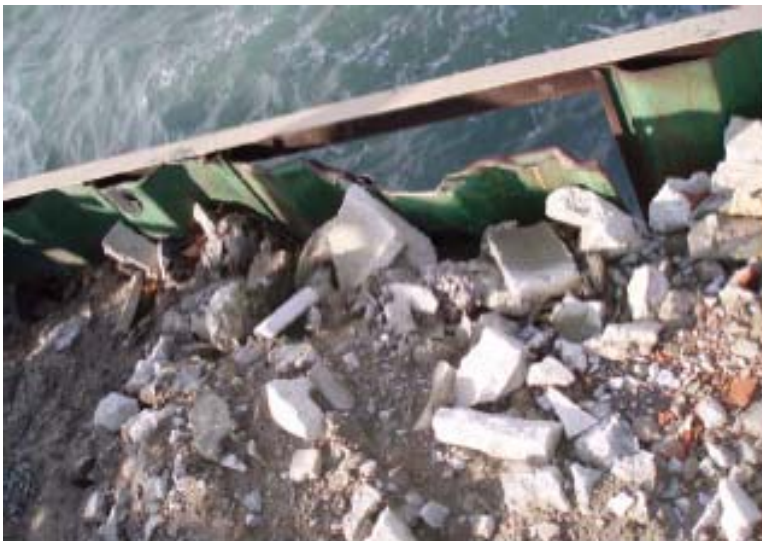
**Photo 3.5.4 - ST0416, Sombra, 2007.**

The three photos of the steel sheet piling walls all show a common problem associated with this type of protection. The crack shown will permit soil loss which will in turn decrease the stability of the adjacent sheets of steel. The white rock/brick in the photo indicates that the property owner has noticed erosion and has done what he/she can do to prevent any more loss. The replacement of the soil can become costly if repairs are not done to the wall. In this case, the wall could either be replaced by a new steel wall or repaired. This would also be a beneficial area to remove and replace with an armour stone revetment depending on the distance between the shoreline and the nearest structure.

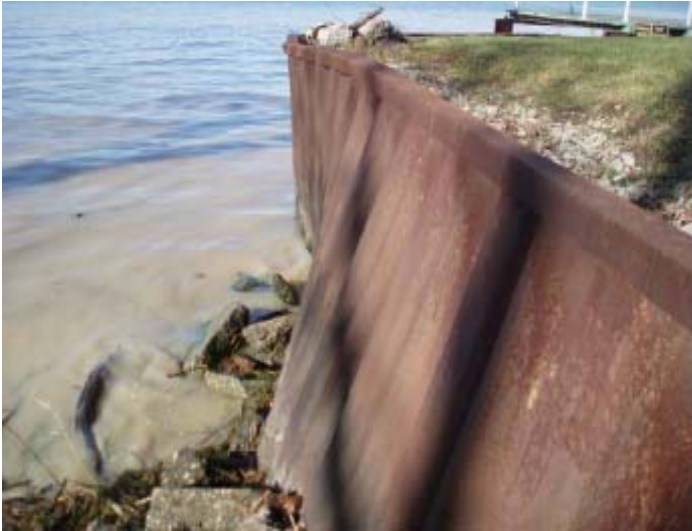
**Photo 3.5.5 – ST0338, Sombra, 2007.**

Photo 3.5.5 shows a wall that is clearly undermined. Because the water level has decreased there is minimal force against the wall maintaining its vertical alignment. The soil behind the wall has slumped and has pushed out the bottom of the wall. In order to prevent this, there must be equal pressure against both sides of the wall. These pressures can be in the form of toe protection or higher water levels.

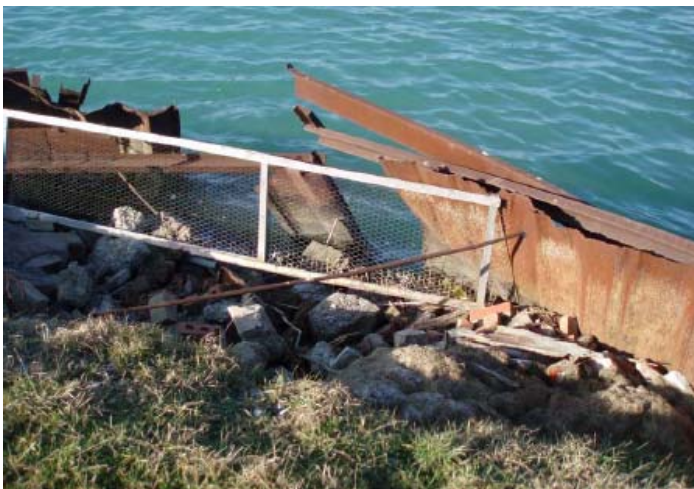
**Photo 3.5.6 – ST0301, Sombra, 2007.**

Photo 3.5.6 shows a wall that is in ruins and in desperate need of repair. The problems associated with this property are due to age of the wall and lack of equilibrium on either side of the structure. This wall is ideal for habitat restoration. On one side of the property is a natural shoreline and the other is a steel sheet piling wall unattached to this one.

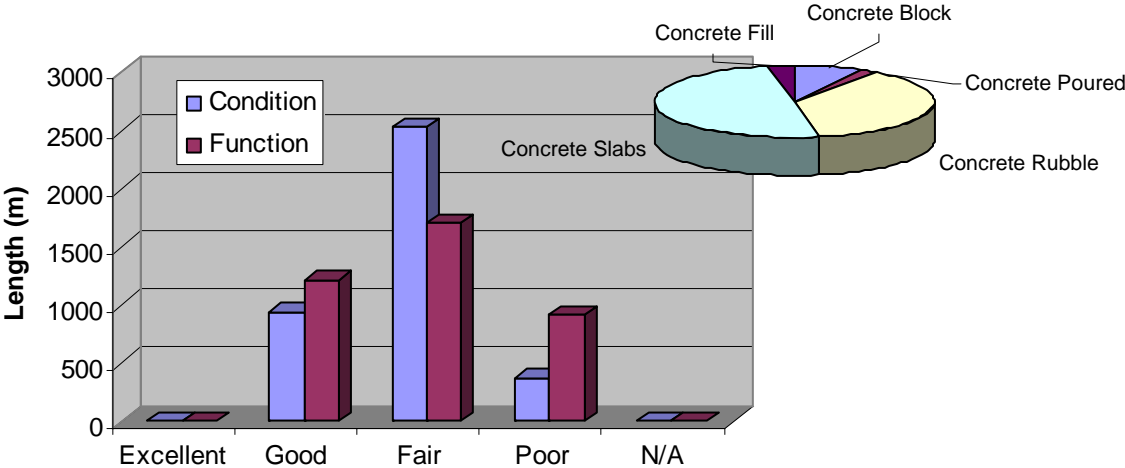
Figure 3.6.2 – Condition, function and composition of concrete protection structures in Port Lambton and the surrounding area, 2007.

Based on the following three graphs the majority of the structures are in good to fair condition and it appears there are few structures that will need to be replaced. The function is worse for both the stone and concrete structures due to age and improper installation. A great deal of the development since 1955 has created steel sheet pile walls and the stone and concrete used may predate this time.

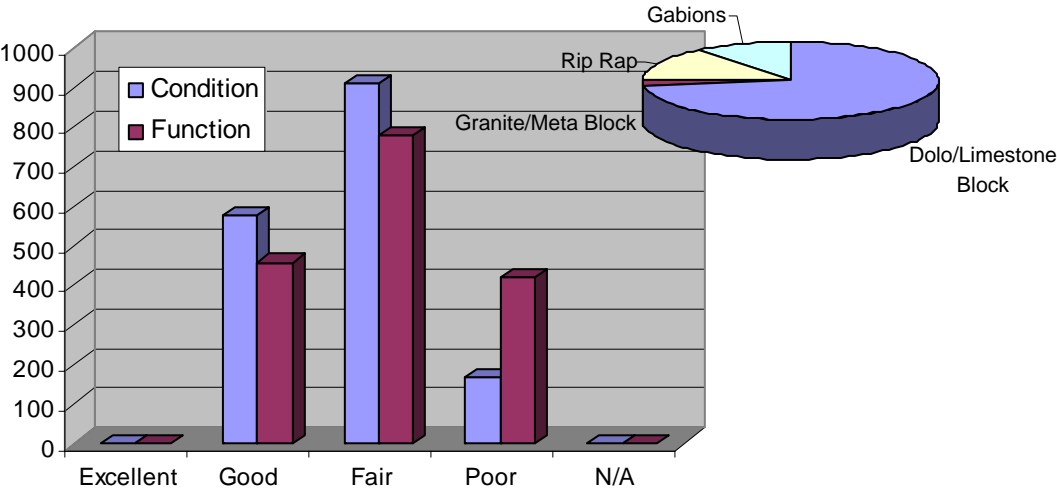
Figure 3.6.3 – Condition, function and composition of stone structures in Port Lambton and the surrounding area, 2007.

The areas of poor conditioned walls are sparse. While looking at the photo of the section, there are only scattered areas of possible restoration with the greatest length being 136m of continuous restoration possibilities. Only 10.6 % (1143.6 meters) is rated poor. Of that, 4.3 % (462.9 meters) are found in the St. Clair River half and 6.3% (680.7) are found in the Chanel Ecarte half.

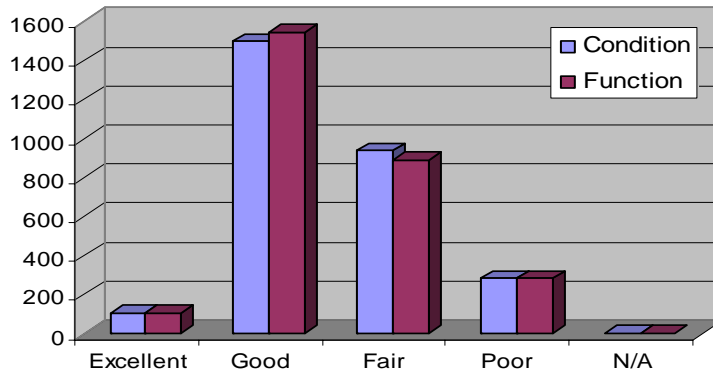
**Figure 3.6.4 – Condition and function of the Steel Sheet Pile walls in Port Lambton and the surrounding area, 2007.**

Comparing these three composition types, we can see that the majority of concrete structures are in fair condition. When concrete is used, it is most often used as a last resort to prevent any further erosion. Concrete is used very similar to stone revetments; a major difference is the use of a design and the installation method. The stone structures are in better condition than the concrete structures, but in worse condition than the steel sheet piling, which we see as having a greater length in good condition than stone and concrete combined.

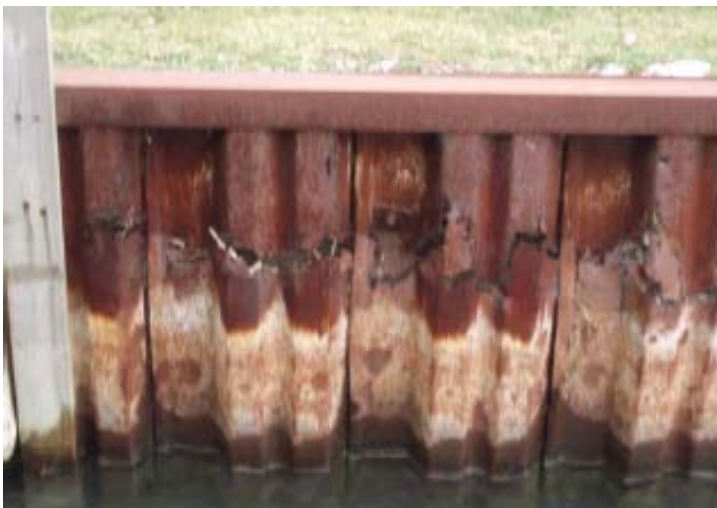
**Photo 3.6.2 – ST0592, Port Lambton, 2007.**

The steel sheet pile wall in photo 3.6.2 is in need of repair due to the rusted areas shown here. This is caused by fluctuating water levels causing oxidation to occur and weakening the steel. This type of problem is uncommon in most steel walls because water levels fluctuate less than the water levels do in this area, meaning that the wall is either consistently above the water or below. This wall will see a great deal of soil loss and may fail if not repaired.

A possible solution is to replace the wall with another steel wall or remove it and replace it with a revetment. The Chanel Ecarte is shallow enough to sustain a rip rap revetment and not used as industrially as the St. Clair river allowing for a longer lifespan of the revetment.

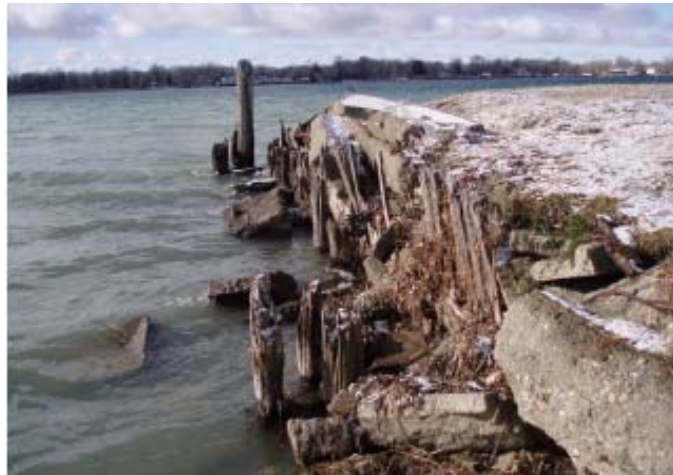
**Photo 3.6.3 – ST0531, Port Lambton, 2007.**

Other areas of possible restoration include two wooden cribs, one found in MacDonald Park along the Chanel Ecarte and another in Port Lambton across from Moore Street. Both photos indicate a great loss of soil. Photo 3.6.3 shows a concrete slab protection behind the timber piles attempting to prevent property loss.

The area in Port Lambton should be repaired as soon as possible to maintain property and control erosion and enhance aesthetic and recreational uses of the site. Due to the distance between the shoreline and roadway, a beneficial revetment can be installed with the appropriate slope.

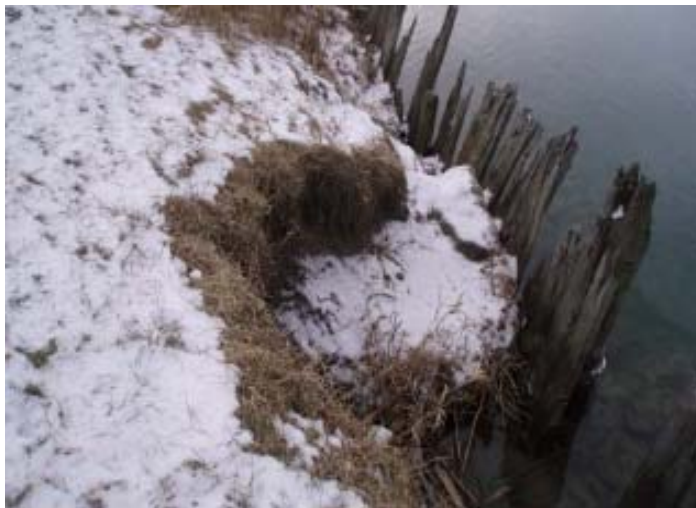
**Photo 3.6.4 – ST0648, McDonald Park, Port Lambton, 2007.**

The shoreline of MacDonald Park has been renovated since our visit. The works included installing gabion baskets to replace the ruins of timber wall. The stacks of gabions baskets will create a wall limiting the soil loss and provide stone creating benthic and fish habitat. MacDonald Park is a public park and will provide a good example of restoration opportunities along the river system.

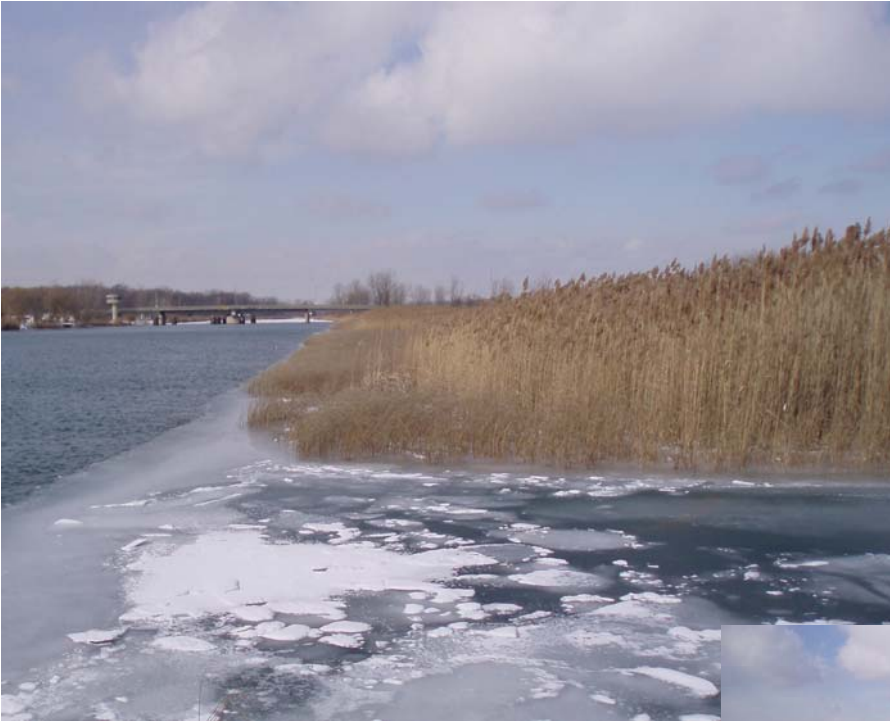
Structure ST0675 is located directly south of the bridge that connects Walpole Island with the main land and is a perfect example how these wetlands have changed over the last fifty years. Before the bridge was built, this wetland area was protected by a dike measuring a distance of approximately 800 metres. By the 1970's, the dike was undermined and the wetland area behind it showed signs of becoming drier. Presently

there are only remnants of the dike and the wetland has been taken over by a field of phragmites.

Left: Side view of ST0675

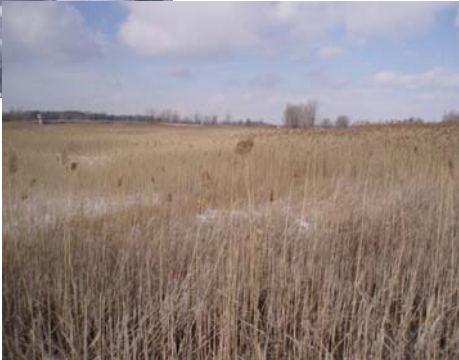
Below: View of wetland from shoreline

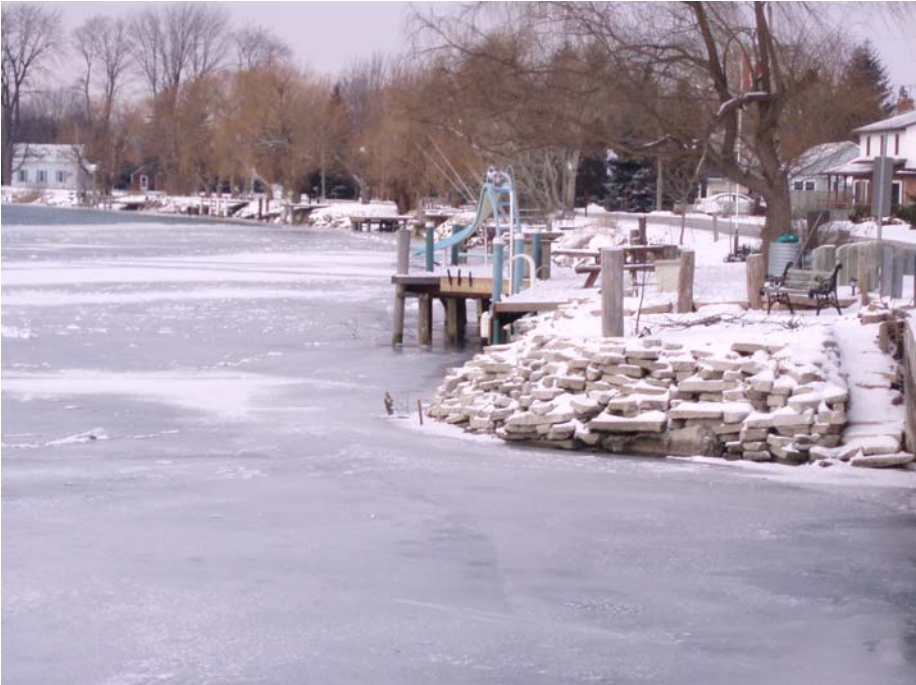
**Photograph of Bluewater Line, where the road has been built on top of the dike.**

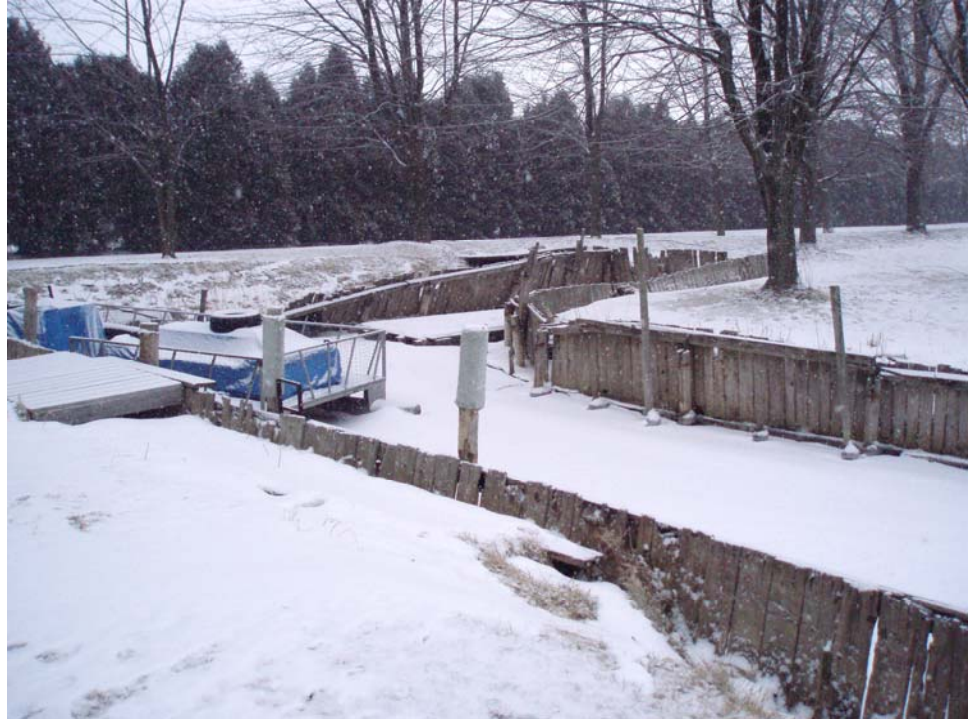
ST0738 Chenal Ecarte, 2007

There may be opportunities to rehabilitate the poorest areas, where the old timber piling shoreline protection is in ruins and there is ample space to introduce a soft shore revetment.

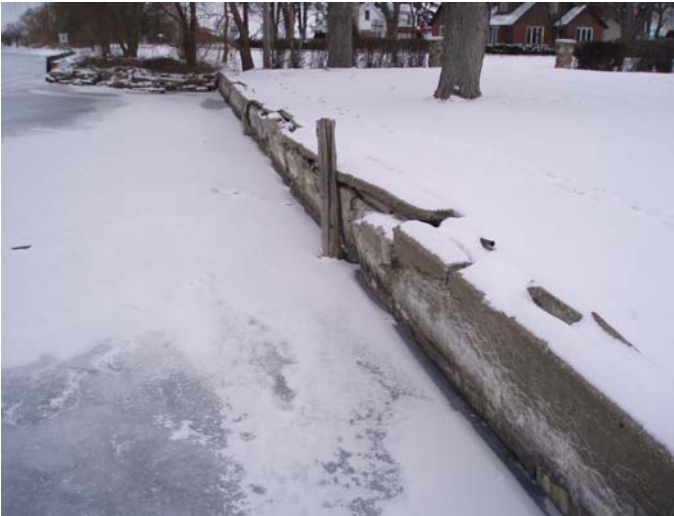
**ST0724 Bluewater Line, 2007**

Other sites include a site where a landowner has a combination of failing structures. The first section has an old concrete slab wall that is beginning to crumble, followed by a flanked timber piling bulkhead. The property ends with a concrete wall in ruins with most of the shoreline exposed and eroding. This property has limited space with an average of 10-12 m to the nearest on-shore structure

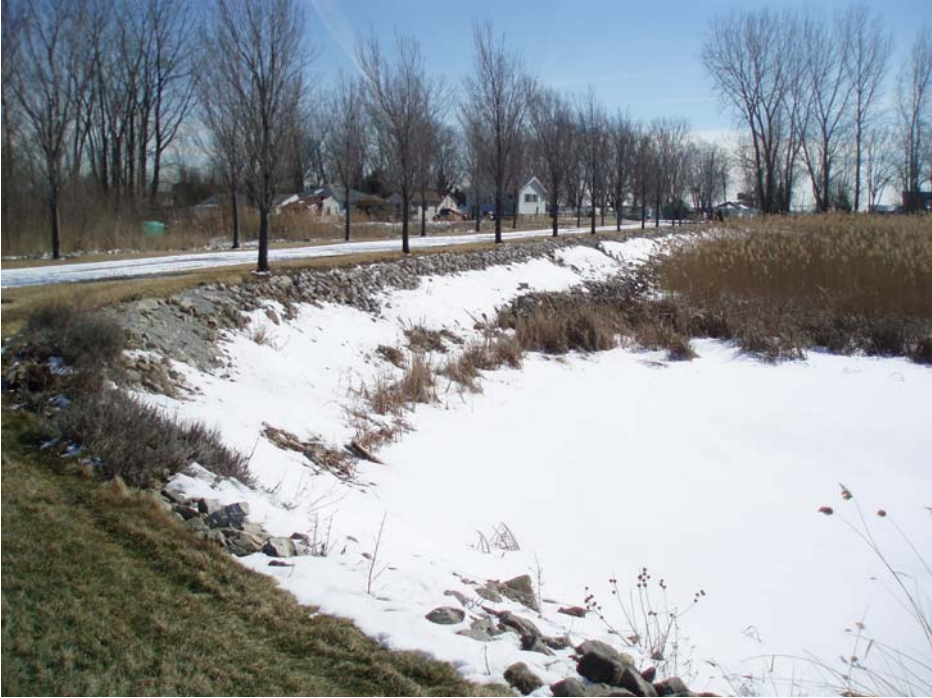
**View of a dike that is also functioning as a road. The stone revetment has been placed for added protection.**

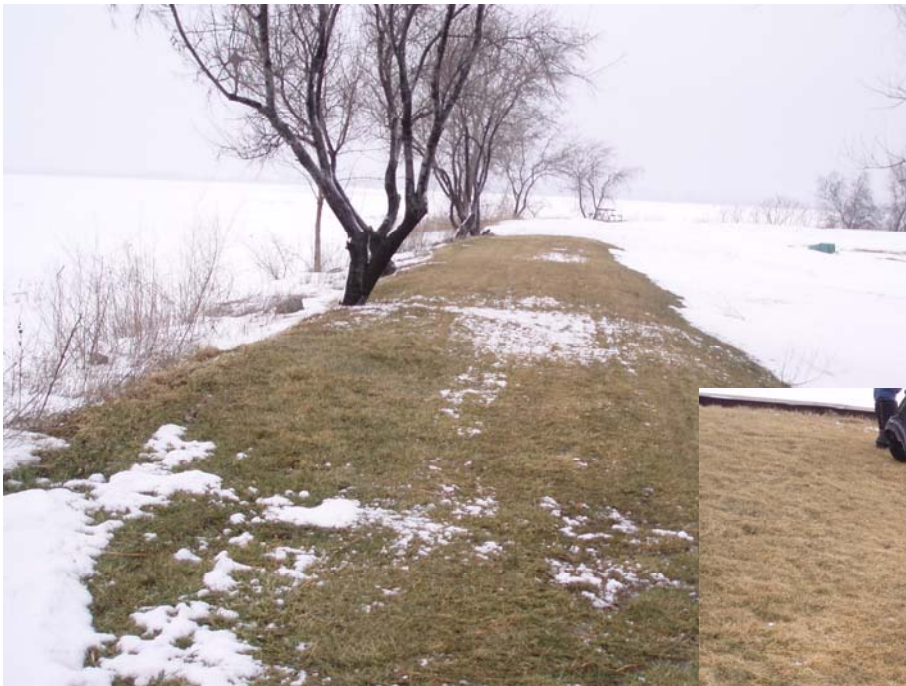
**ST00775, Marine Park 2007**

Two parks in particular that are located close to the Marina and Wharf would be excellent candidates for shoreline rehabilitation. In both areas, the shoreline protection that is in place is failing, and as a result valuable parkland is being lost. Restoring these areas would stabilize the shoreline as well as making it more aesthetically pleasing.

Erosion along dike and flanked steel walls  
at Marine Park
